**Total Land Subsidence in the Hawk Rock Area, Maricopa and Pinal Counties**  
**Based on Radarsat-2 Satellite Interferometric Synthetic Aperture Radar (InSAR) Data**  
**Time Period of Analysis: 1.0 Years 04/13/2016 To 03/15/2017**

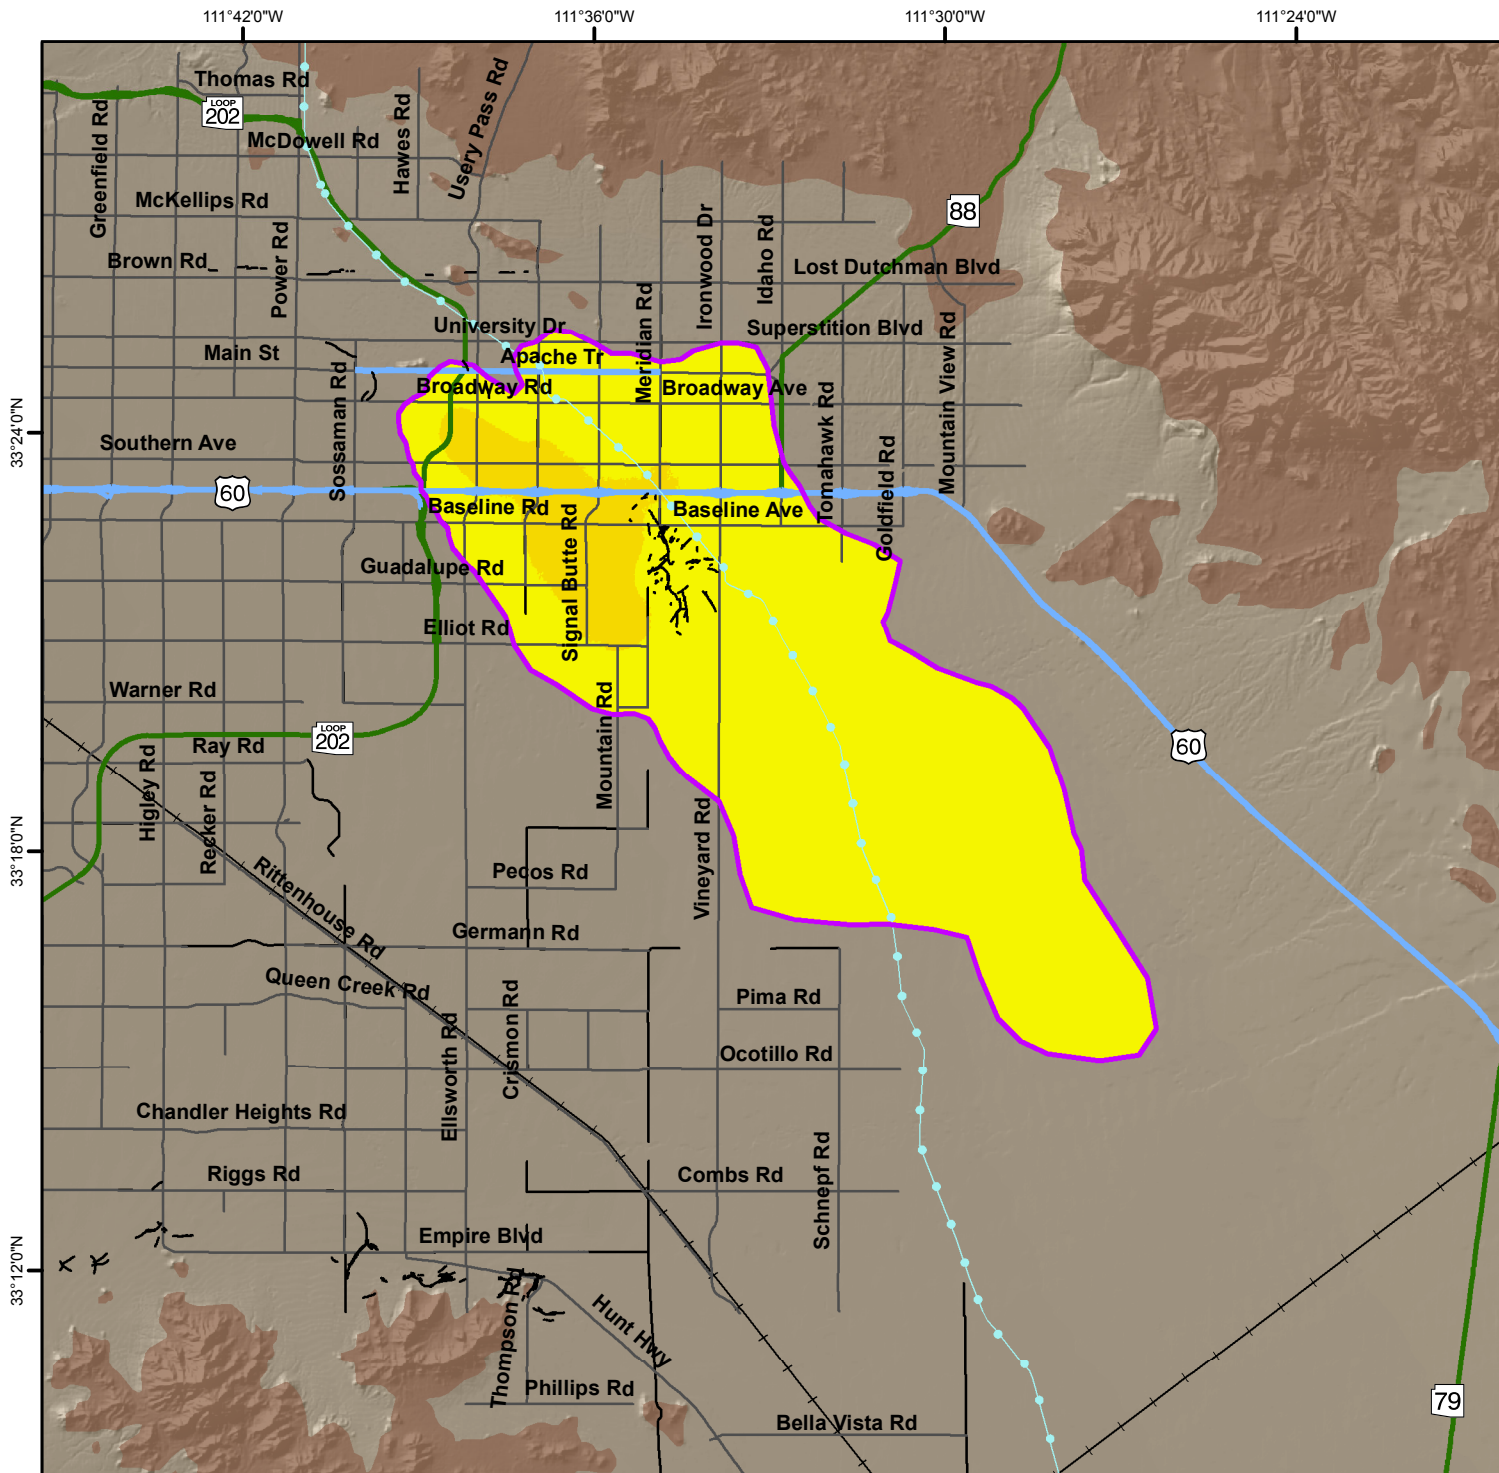
Decorrelation (white areas) are areas where the phase of the received satellite signal changed between satellite passes, causing the data to be unusable. This occurs in areas where the land surface has been disturbed (i.e. bodies of water, snow, agriculture areas, areas of development, etc).

Earth fissures were mapped by the Arizona Geological Survey.  
 For information on earth fissures visit: [www.azgs.gov/EFC](http://www.azgs.gov/EFC)
